Survey, Investigation and Repairing on Concrete Wall of Waste Water Treatment Building

Waste Water Treatment Building (WWTB) of Multinational Company located in Cikande, Banten

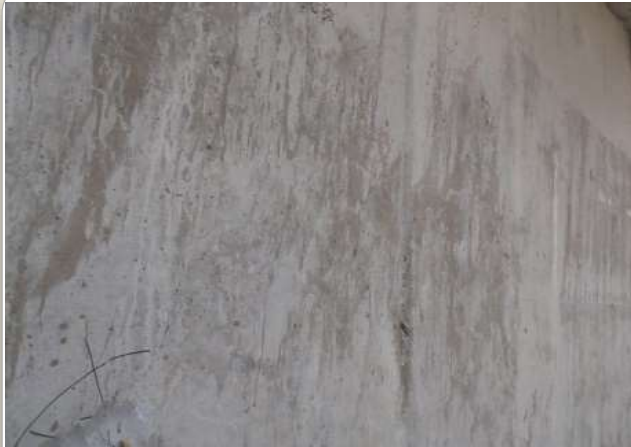
surface area seepage on the wall W1

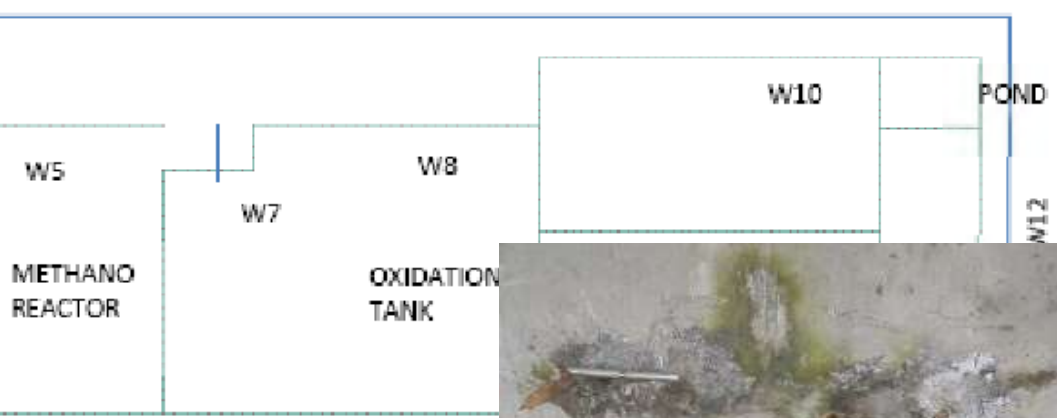
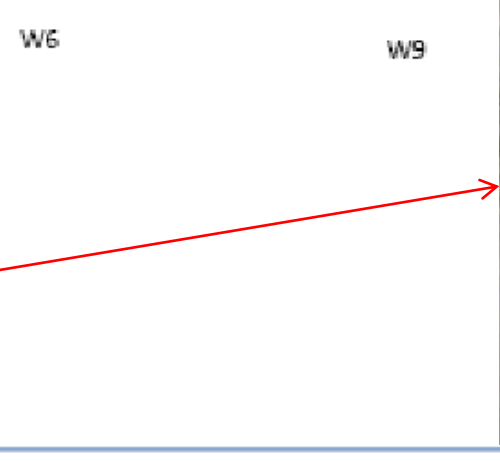
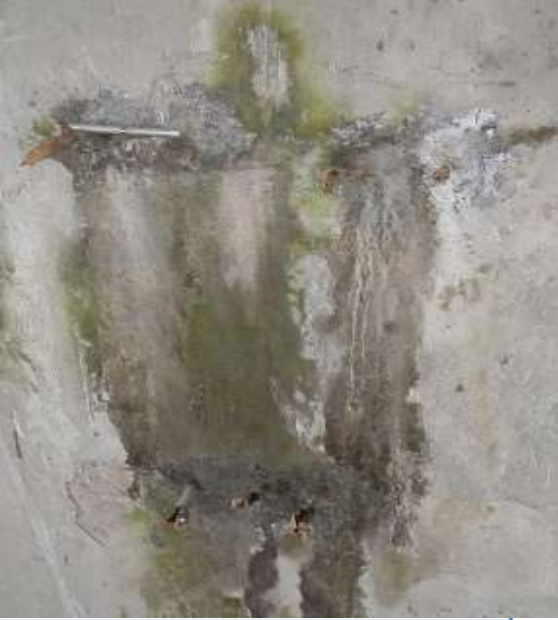
spot seepage on the wall W2

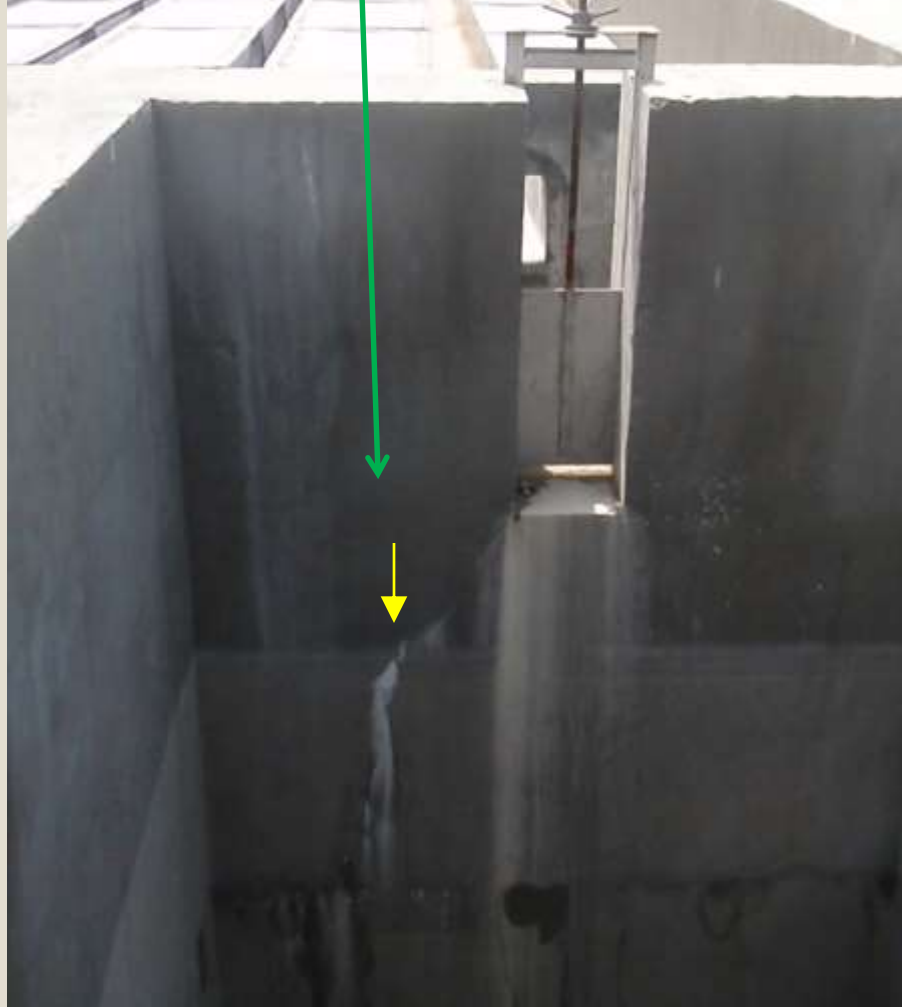
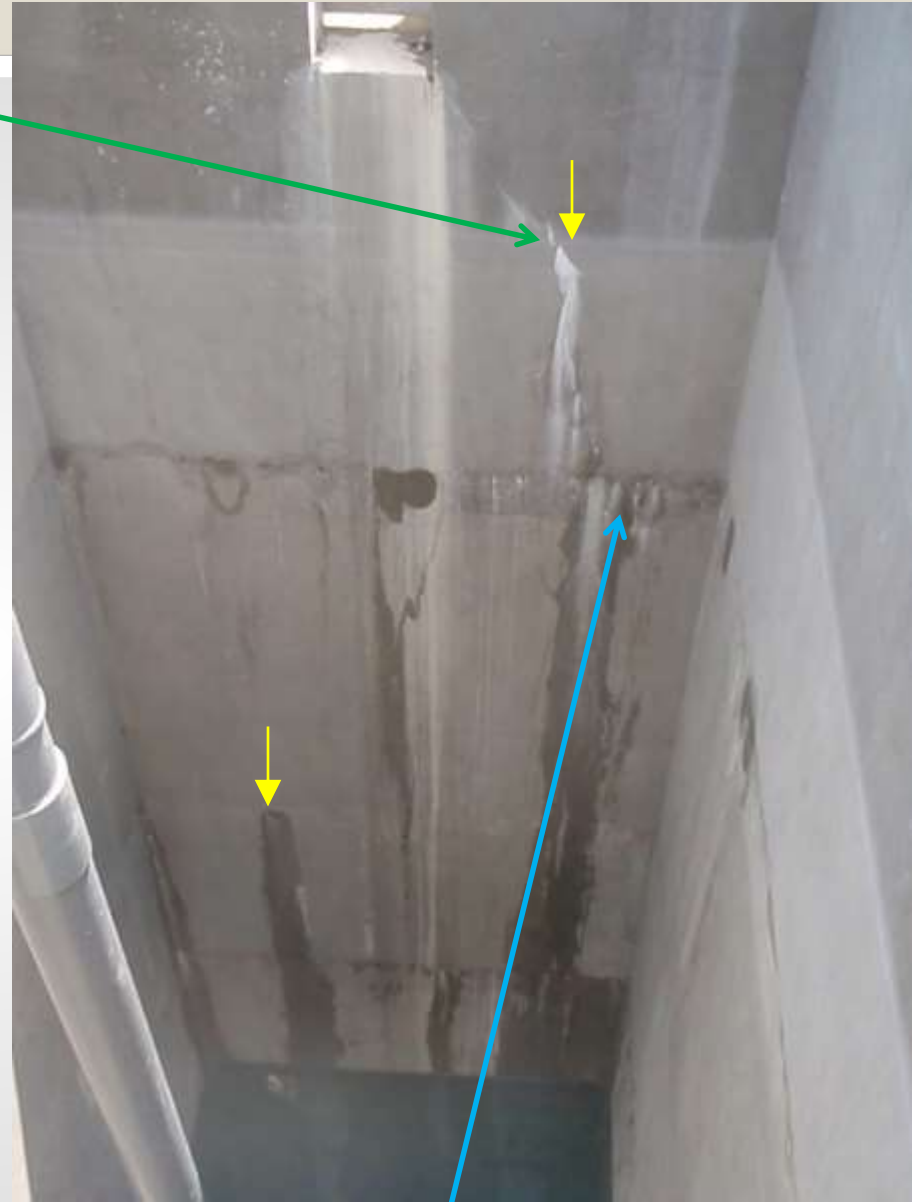
THE INDICATION OF THE
SEGREGATION IN CONCRETE

ALKALINE REACTION HAPPENED

Cement based waterproofing was not working

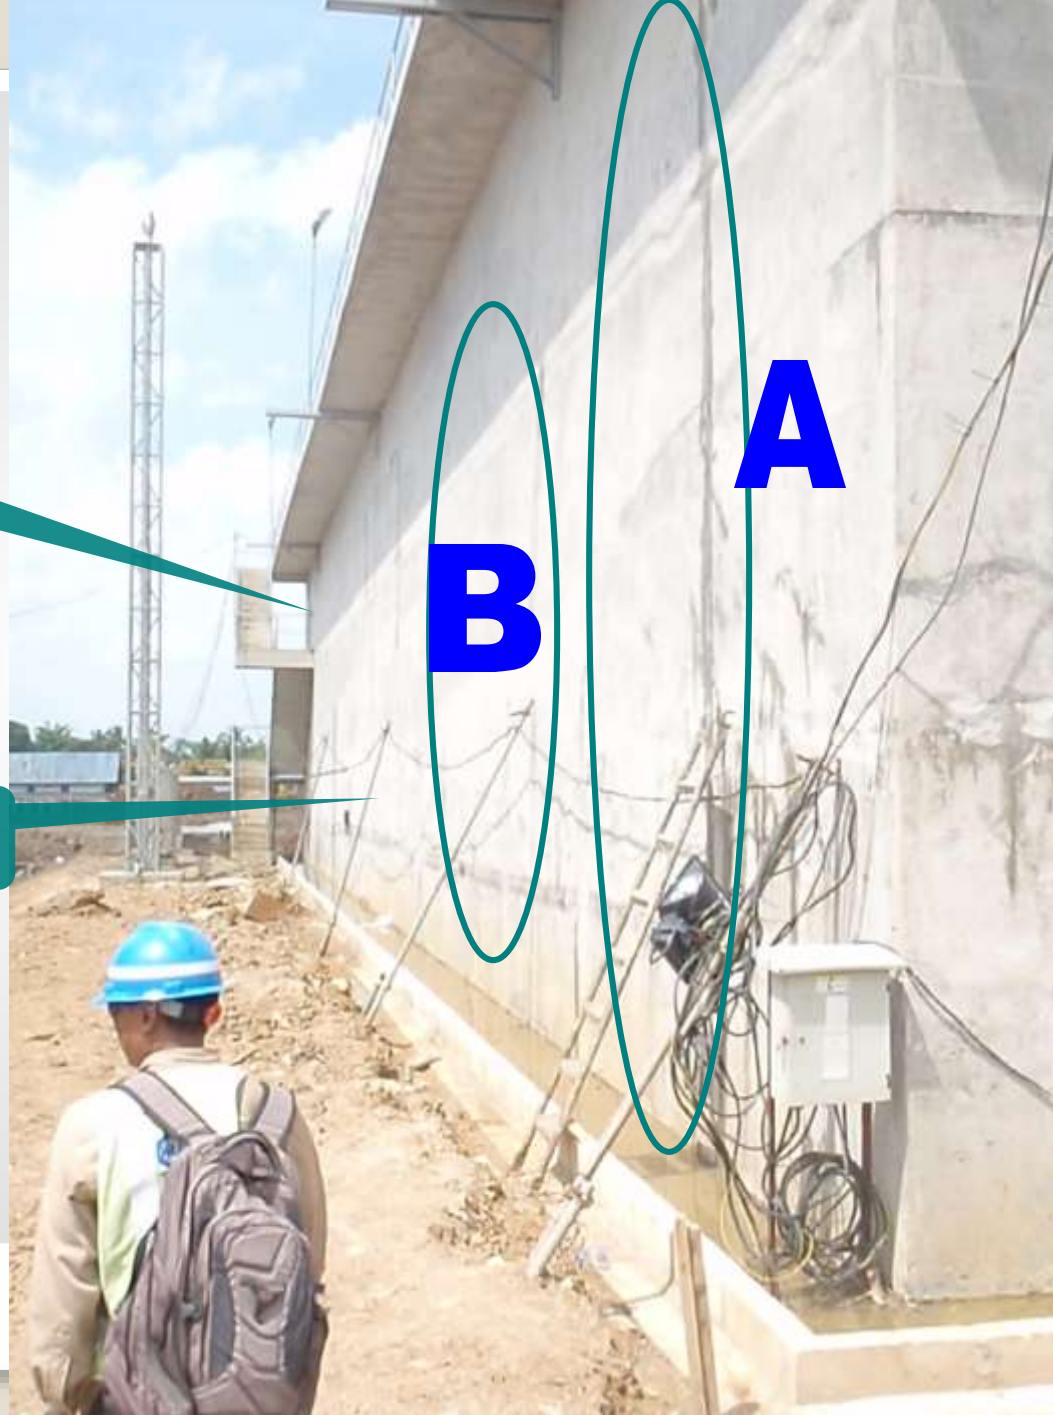
SOME CRACKS

VERTICAL CRACK

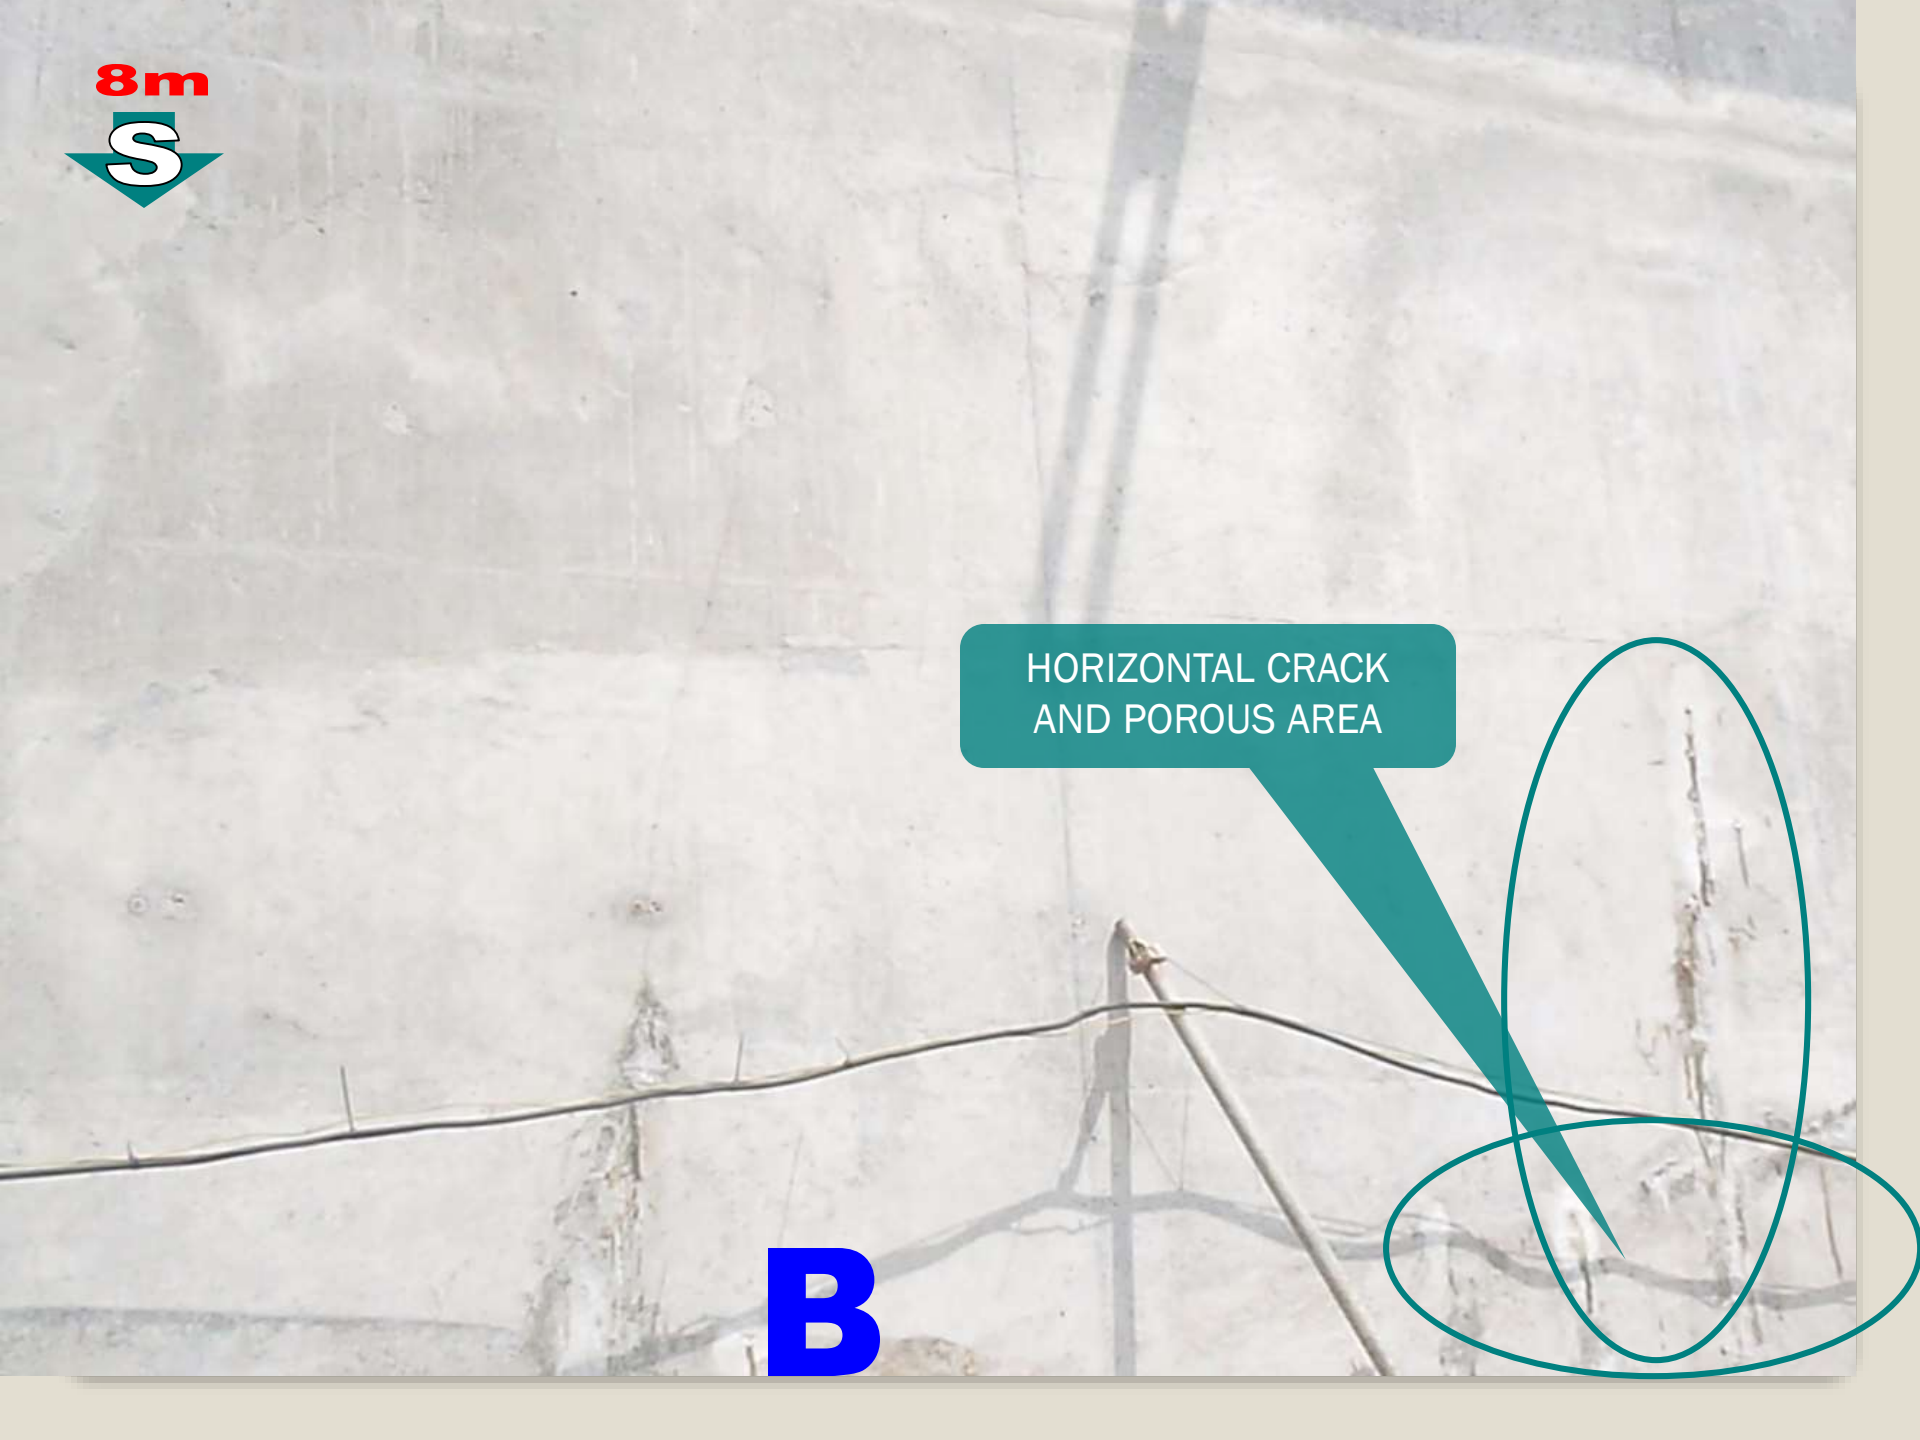
HORIZONTAL CRACK
AND POROUS AREA

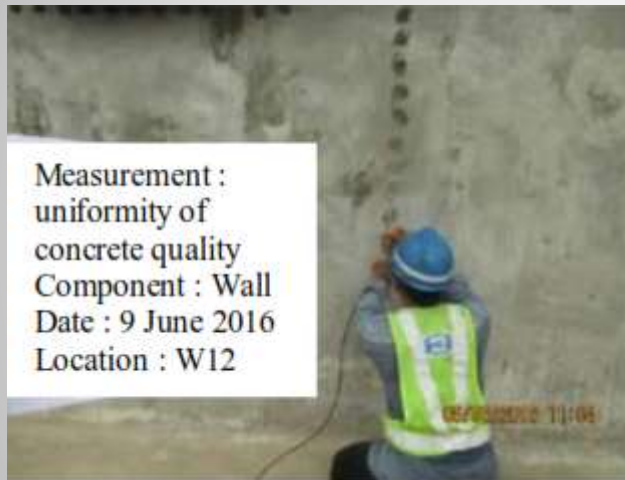
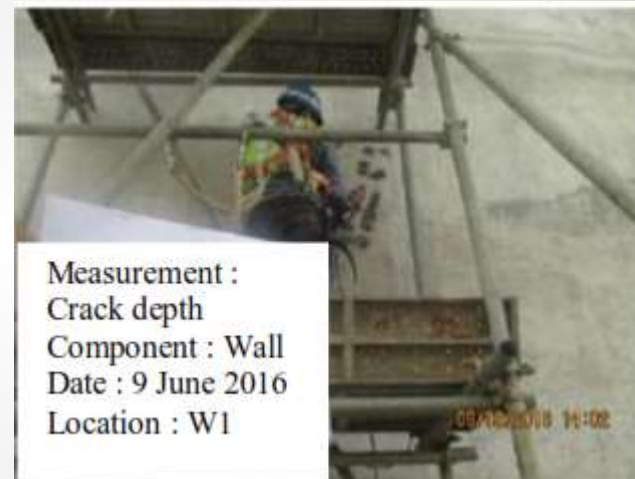
No	Location/Wall	V	uniformity of concrete quality
		(km/sec)	
1	Vertical/wall W12	3,24	pretty good
2	Horizontal/wall W12	2,34	enough
3	Horizontal/wall W1	3,05	pretty good
4	Vertical/wall W1	3,32	pretty good
5	Vertical/wall W3	2,99	enough

From the results of crack depth testing of wall W1, the average crack depth of **102.5 mm** was obtained

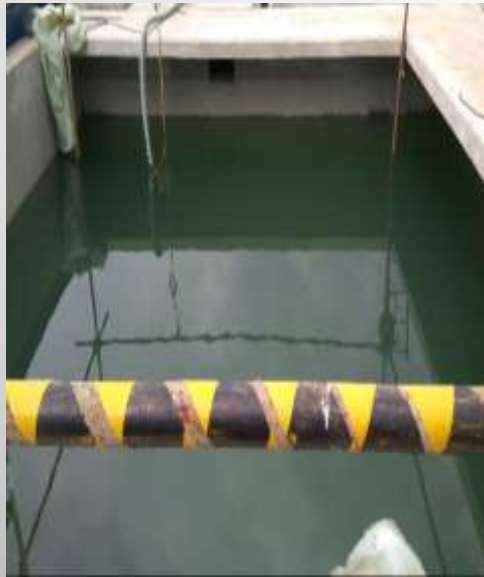
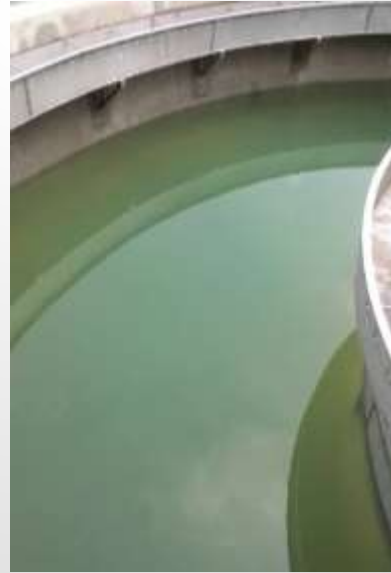
The pond testing was conducted for 14 days. Based on the test results, there was no leakage and seepage during the pond testing. WWTB was ready to use
