Performance Evaluation of a Trunk-A Road in North Central Nigeria

A trunk-A road of about 120km, spanning through Bida basin, within Niger State of Nigeria, was recently rehabilitated by complete reconstruction in 2015. The reconstruction essentially involved resurfacing of the entire stretch of the road, with complete replacement of base and sub-base course materials at portions where complete failure was observed. Where base course was replaced, stone base was used as against lateritic material, used on the existing road. Before the replacement, the strength of the resultant sub-base and subgrade were tested using Dynamic Cone Penetration Test (DCPT). Thereafter, the entire road was resurfaced with quality asphalt concrete. In July 2017, a performance evaluation was carried out at five selected positions within the road to assess the strength and stability of the road after two years of reconstruction. This was done by coring the asphalt concrete for complete pavement evaluation and conducting DCPT below the hole created by the corer from the base course through the sub-base course to the sub-grade course. The results obtained from both the pavement evaluation as well as the Dyn

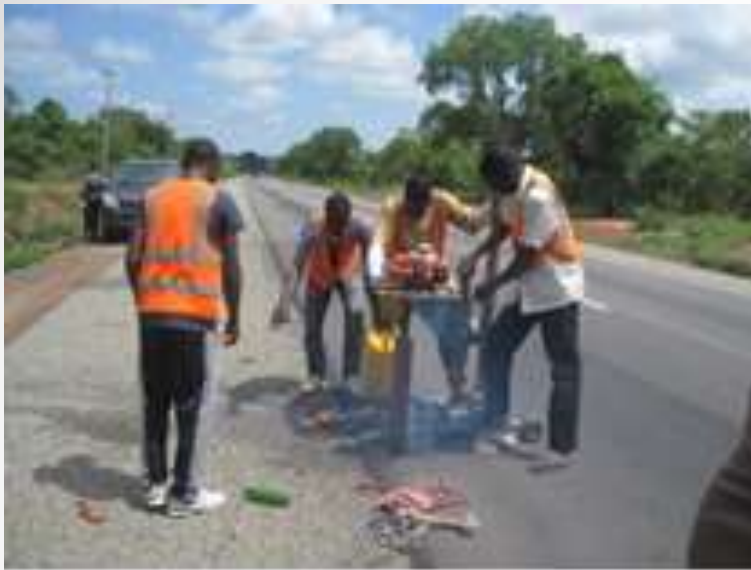
Figure 1: Coring through the pavement structure

- ▶ The field work involved carrying out the following operations at five different identified locations (CH 18+600, CH 25+800, CH 55+550, CH 68+00 and CH 84+400) along the road:
 - Coring through the pavement structure (Figure 1);
 - Collection of core samples of asphalt (Figure 2);
 - Evaluation of thicknesses of asphalt, base and sub-base courses;
 - Dynamic Cone penetration (DCP) test (Figure 3) to infer CBR values of Base, Sub-base and Sub-grade.

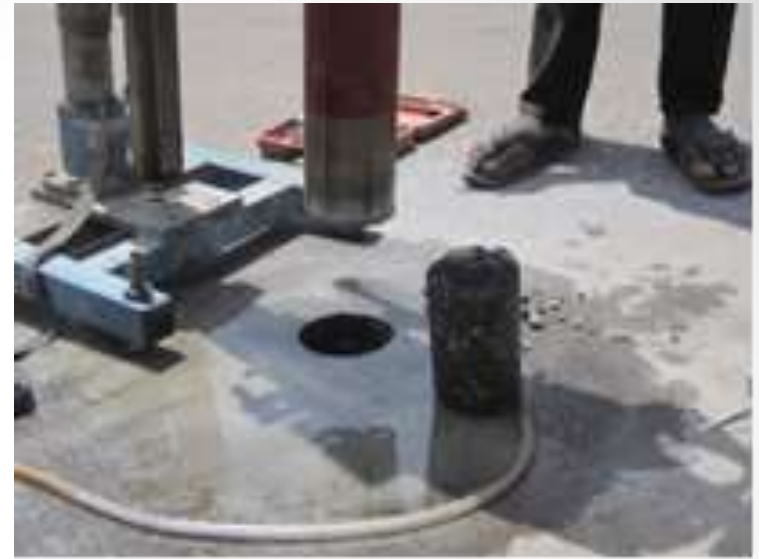
Figure 2: Collection of core samples of asphalt

Location of Core	Unit weight (gm/ml)	Specific gravity	Marshall Stability (kN)	Flow (mm)	Bitumen content (%)		Void ratio	Percentage void filled with bitumen (%)
					By total	By Aggregate		
CH 18+600	2.56	2.71	3.47	3.8	8.0	8.7	5.45	75.34
CH 25+800	2.56	2.69	3.47	3.8	6.2	6.6	4.85	72.72
CH 55+550	2.56	2.69	3.19	3.8	5.9	6.2	4.85	71.72
CH 84+400	2.56	2.69	3.25	3.8	8.9	9.8	4.85	72.72

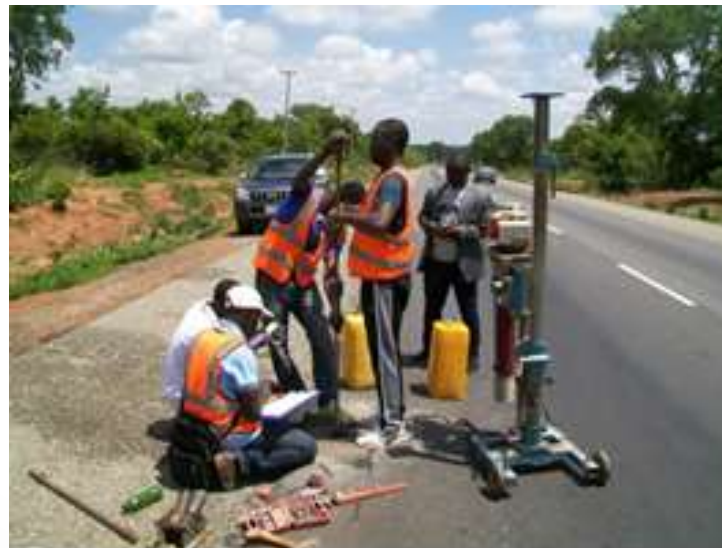
Figure 3: Dynamic Cone penetration test

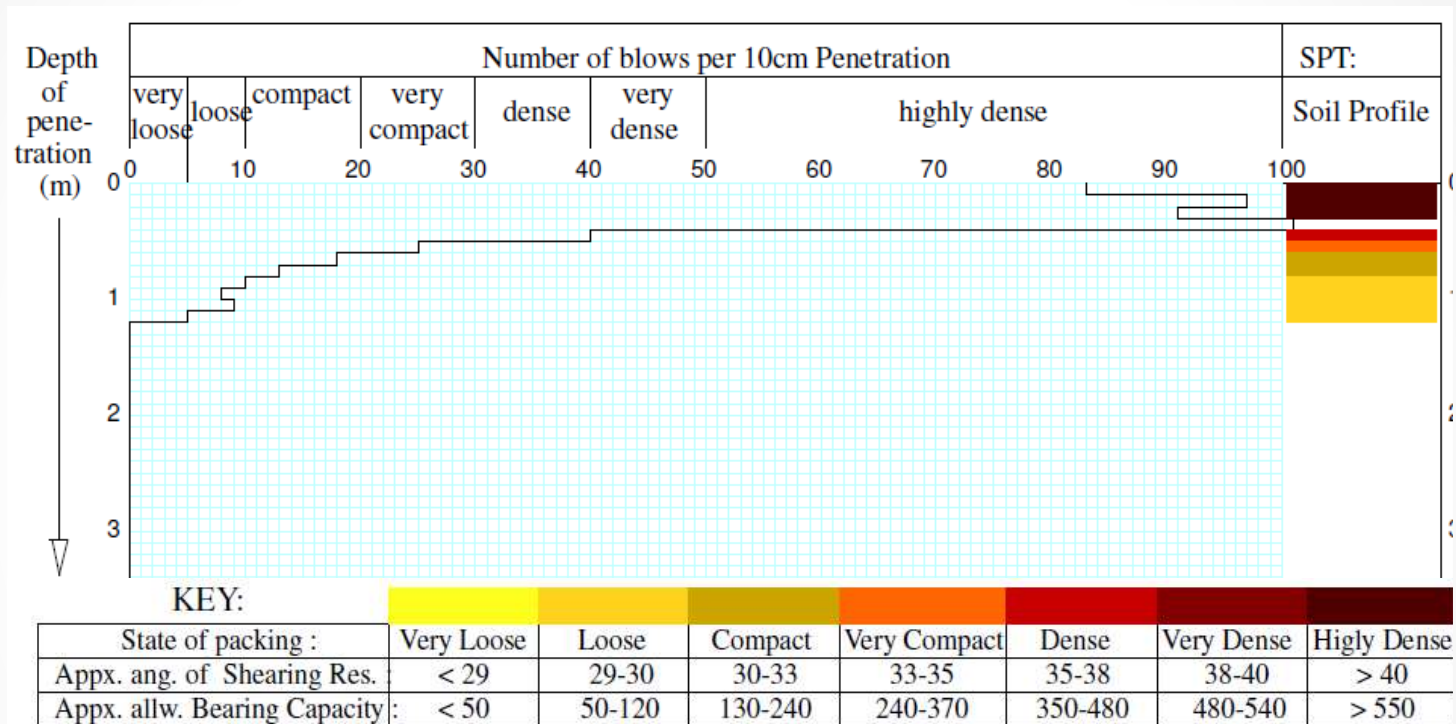
Figure 4: DCPT Result for test location one (CH 18+600)

LOCATION OF CORING			ASPHALT			Base Course		Sub-base Course		Sub-grade	
Chainage	GPS		Thickness of Binder (mm)	Thickness of Wearing (mm)	Total Thickness (mm)	Thickness (mm)	Average CBR (%)	Thickness (mm)	Average CBR (%)	Thickness (mm)	Average CBR (%)
	N	E									
CH 18+600	9°16'49.68"N	5°17'8.70"E	55	40	95	200	180	200	193	600	35
CH 25+800	9°16'3.45"N	5°20'47.52"E	102	50	152	200	81	200	64	600	43
CH 55+550	9°8'2.19"N	5°32'24.08"E	95	40	135	200	167	200	187	600	77
CH 68+000	9°12'8.72"N	5°35'39.60"E	90	40	130	200	159	200	180	600	91
CH 84+400	9°12'16.44"N	5°43'47.82"E	72	40	112	200	167	200	155	600	184

- ▶ The results obtained from both the pavement evaluation as well as the Dynamic Cone Penetration tests were compared with those carried out during reconstruction.
- ▶ It was observed that the two results have very good agreement. However, one position showed slightly lower strength, probably due to the influence of erected speed bump on this position.
