Comprehensive condition assessment program on the fire damaged structure – a project case in Singapore

*4th International Conference on Rehabilitation and Maintenance in
Civil Engineering
Solo Baru, July 11th – 12th 2018*

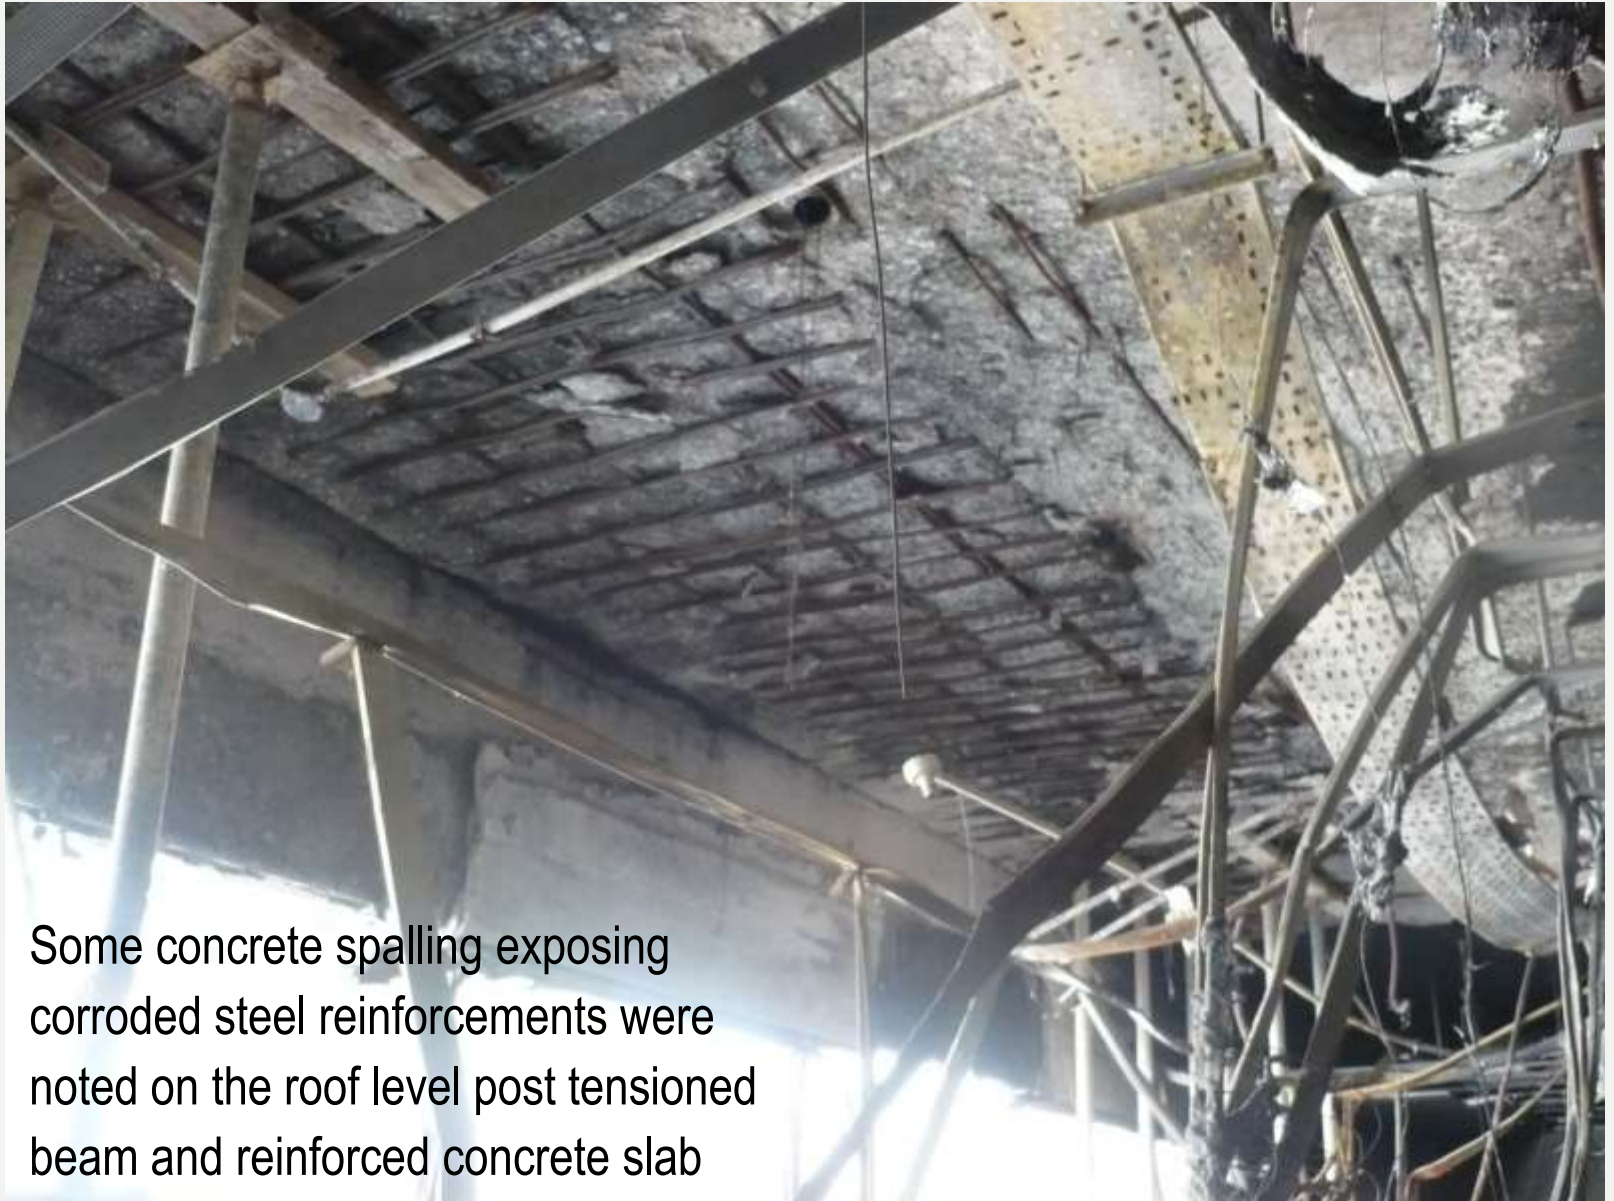
Some concrete spalling exposing corroded steel reinforcements were noted on the roof level post tensioned beam and reinforced concrete slab

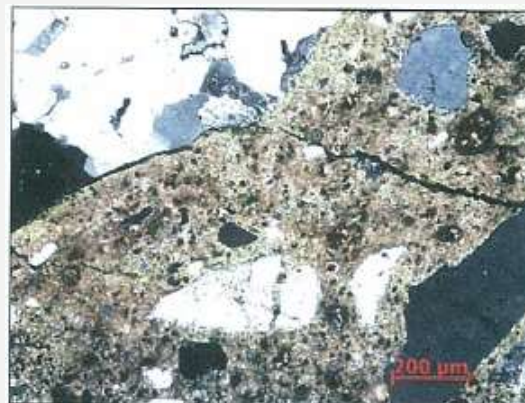
- Petrographic examinations were performed on seven (7) submitted core samples to determine the extent of the concrete damage. All samples were analyzed starting from the sample surface exposed to the fire.
- Carbonation was noted within the 5mm depth.
- Some micro cracks were noted on the cement paste. Some of these were not fire-induced cracks which occurred before the fire.

(a) Under plane polarized light

(b) Under cross polarized light

(c) Under fluorescent light

- Some micro cracks were noted inside the cement paste within 20mm from the exposed surface. Some of these micro cracks were existing cracks which occurred before the fire whereas some were fire-induced. Some aggregate-cement paste debonding was observed on the existing micro cracks within 20mm from the exposed surface. However, no cracks were observed on the aggregates. The concrete at the depth of more than 20mm was considered to be in good condition as no signs of distress were observed.
- Petrographic examination suggested that the top 5mm of the concrete surface might be exposed to a temperature not more than 450°C. The remaining depth of the concrete was strongly believed to be exposed to a temperature of less than 300°C.
