Technical Audit on Operation and Maintenance Needs in Tlatak Irrigation Area in Magetan Regency of East Java

Surakarta, 11 July 2017

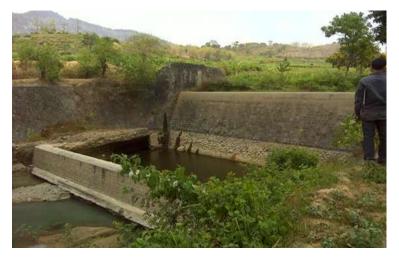
- Irrigation water needs in Tlatak are not met.
- Based on information and field surveys, non-fulfillment of irrigation water requirement in irrigation area of tlatak resulting from a lot of water taking unrecorded discharge and duration and there is damage to irrigation channel infrastructure, so that water can not be distributed optimally.

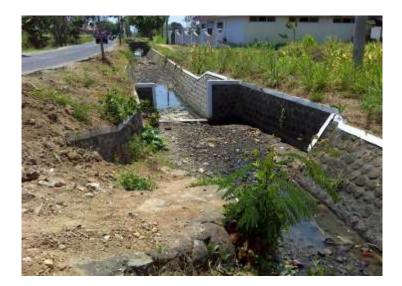
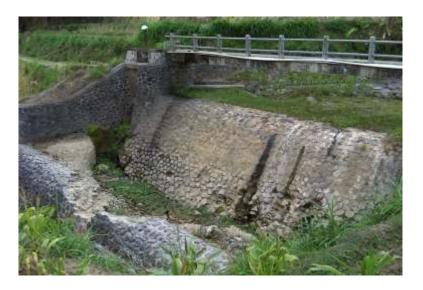
The capacity of each channel is not enough to distribute water discharge. This is evidenced by the value of irrigation efficiency 74,24 %. The value is below the government set value for the secondary channel of 90%.

- 1. Improvements to the destruction of irrigation channel
- **2.** Improvements to the buildings that were damaged
- **3. Adding water source source to deep wells**
- 4. Increasing participation of water user from farmer associations
